Case Study of the Remediation of Padloping Island and FOX-E, Durban Island Sites in Nunavut

Presentation Overview

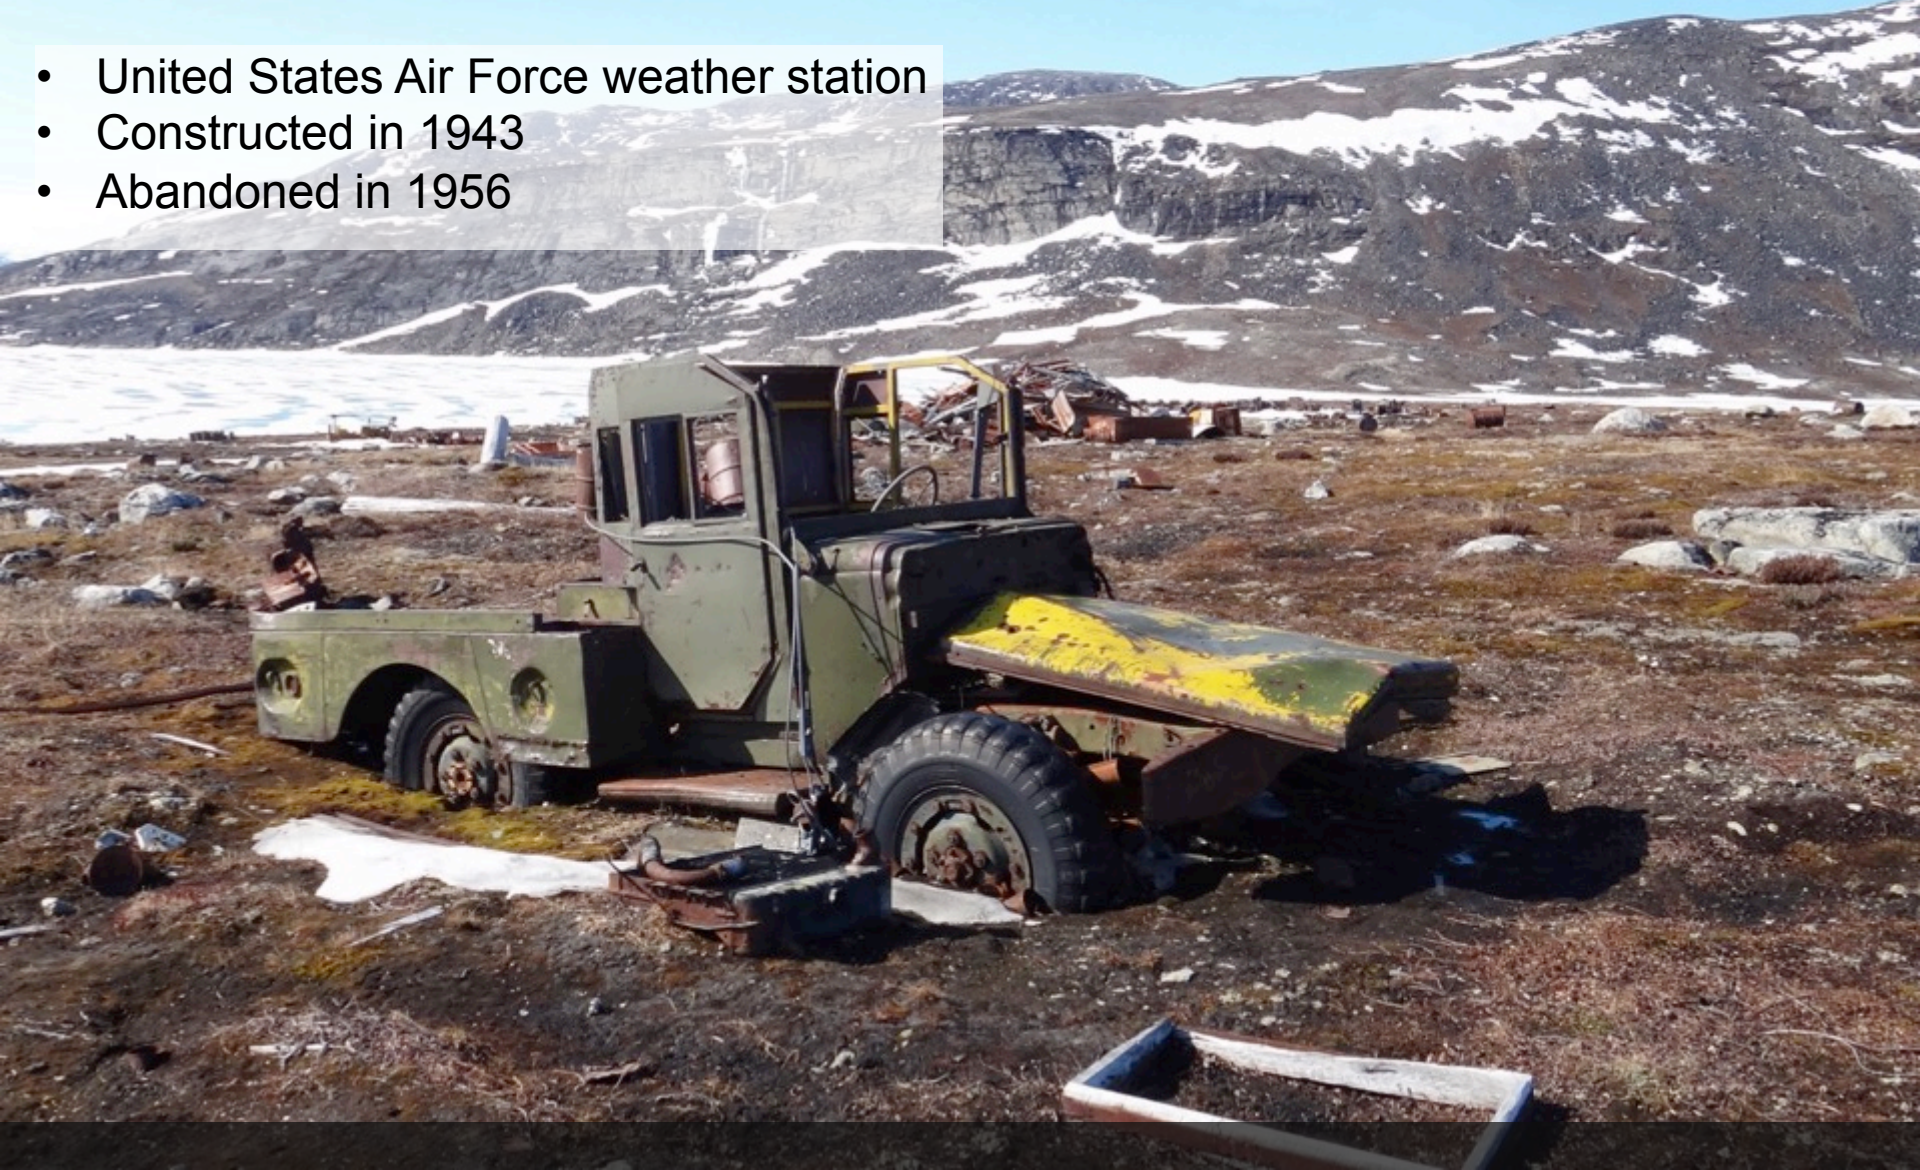
Padloping Island – Former Weather Station

- United States Air Force weather station
- Constructed in 1943
- Abandoned in 1956

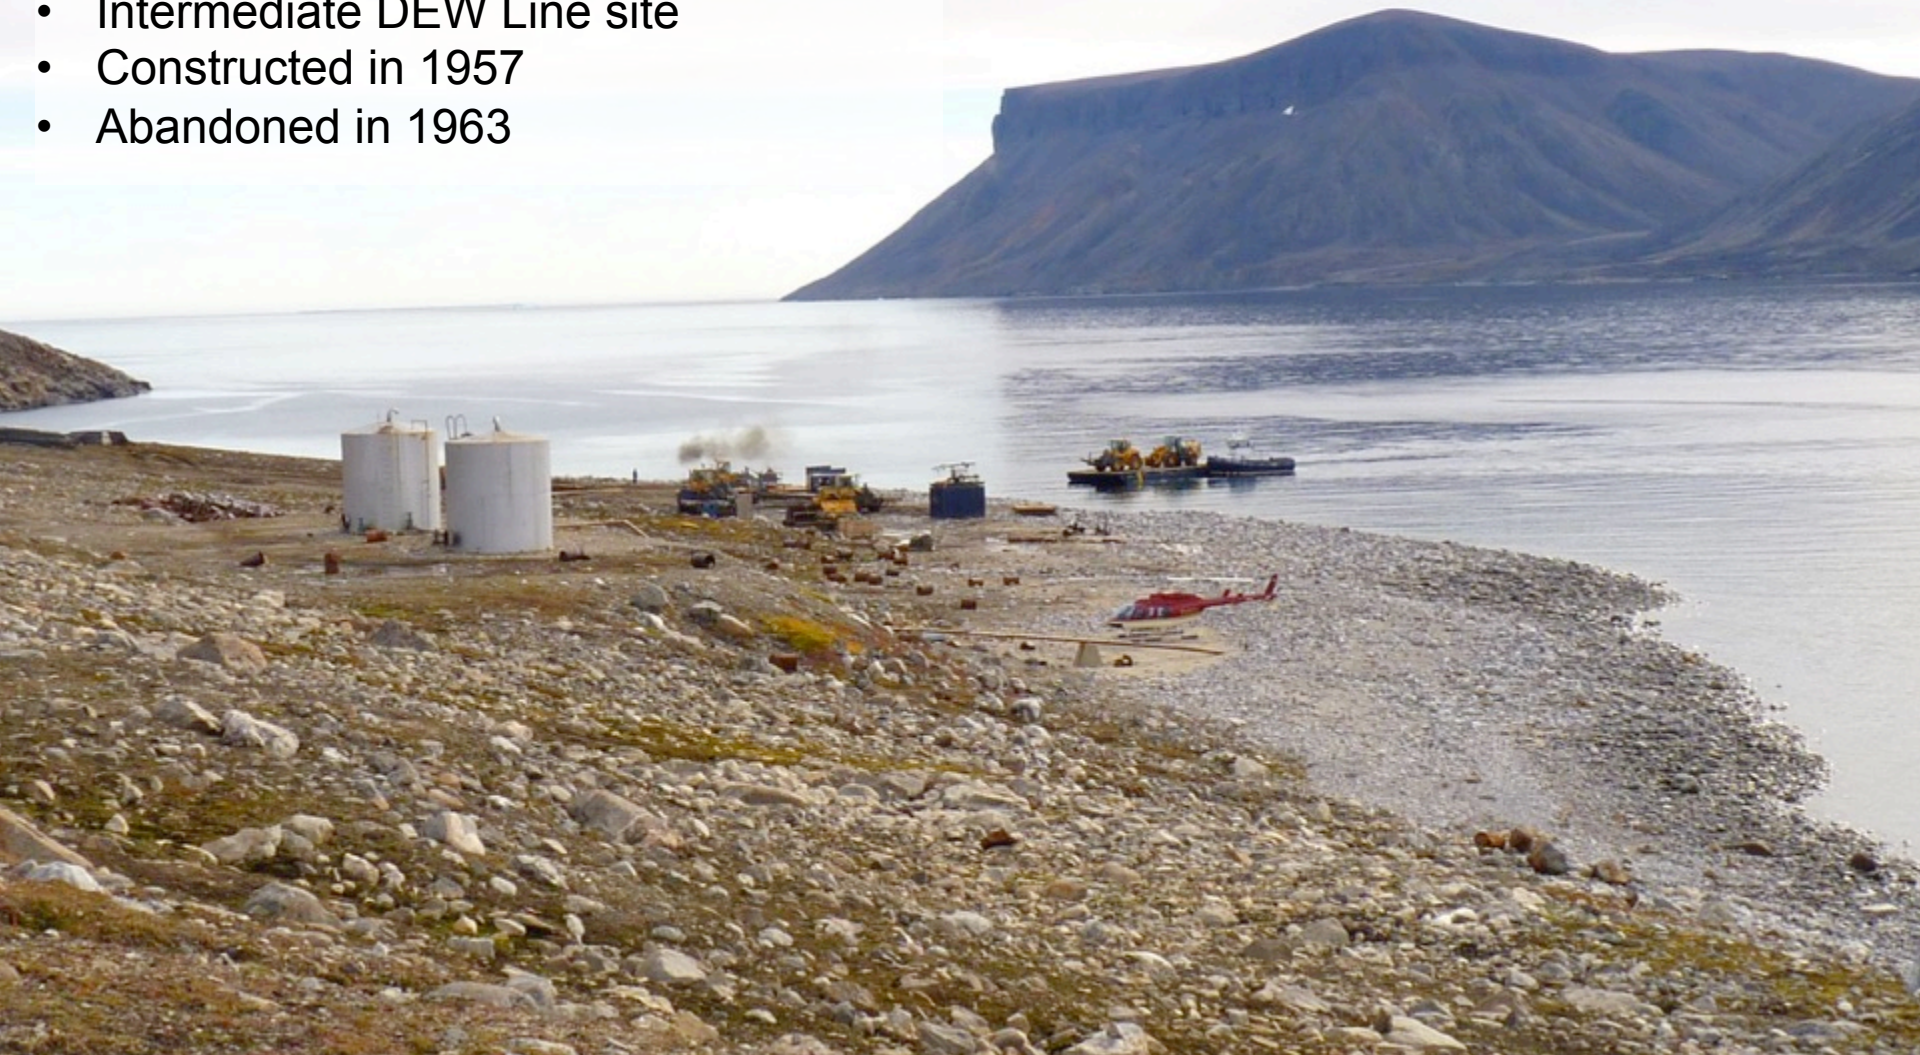
FOX-E, Durban Island – Intermediate DEW Line Site

- Intermediate DEW Line site
- Constructed in 1957
- Abandoned in 1963

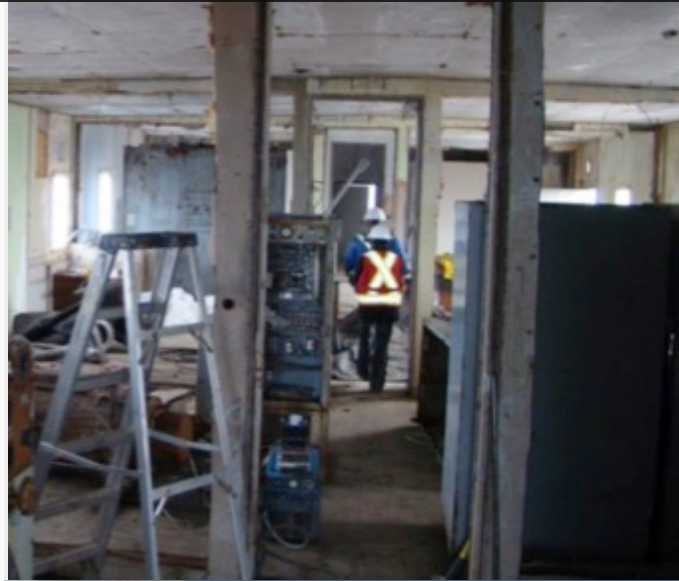
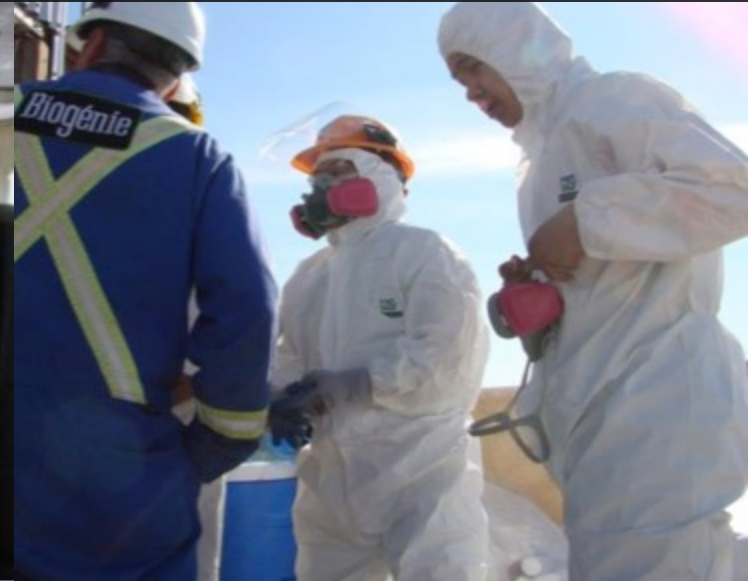
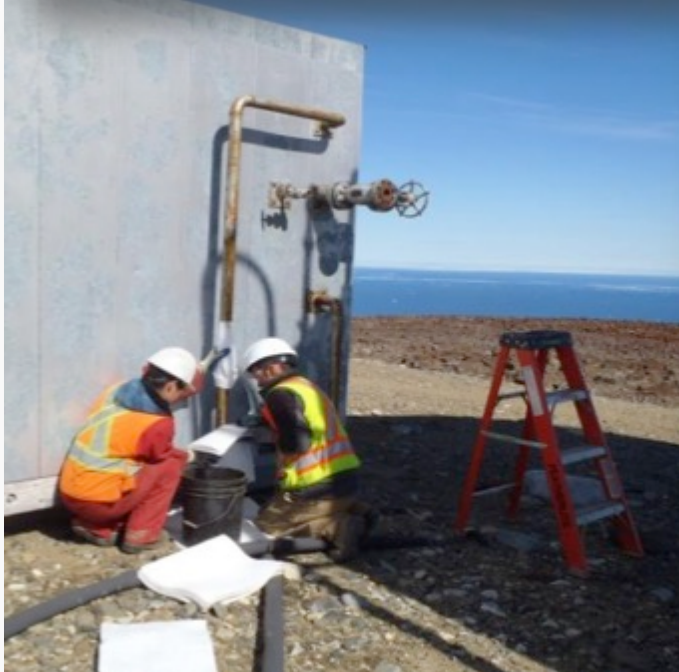
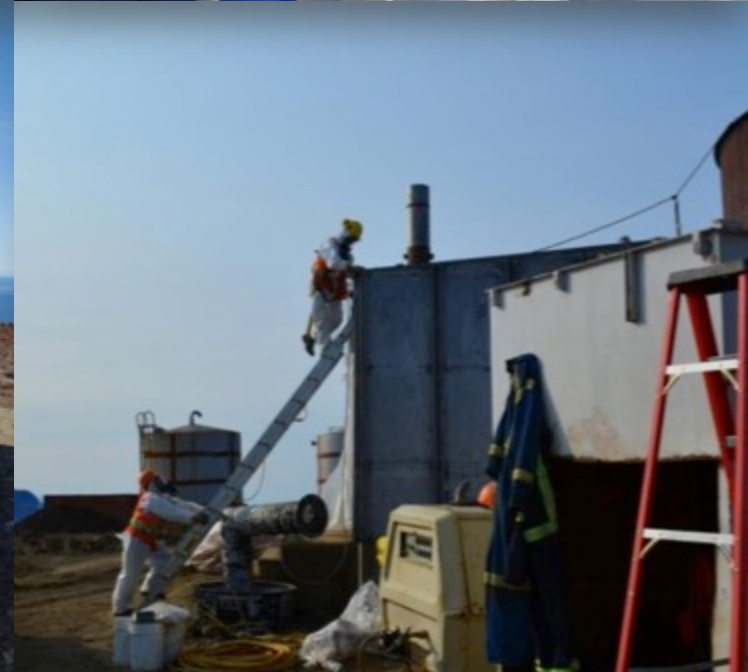
Hazardous Materials Abatement

- PCB Amended Paint (PAP)
- Leachable Lead Amended Paint
- Asbestos in doors, wall panels, pipe wrap
- Fuel tanks and POL lines containing fuel
- Compressed gas cylinders

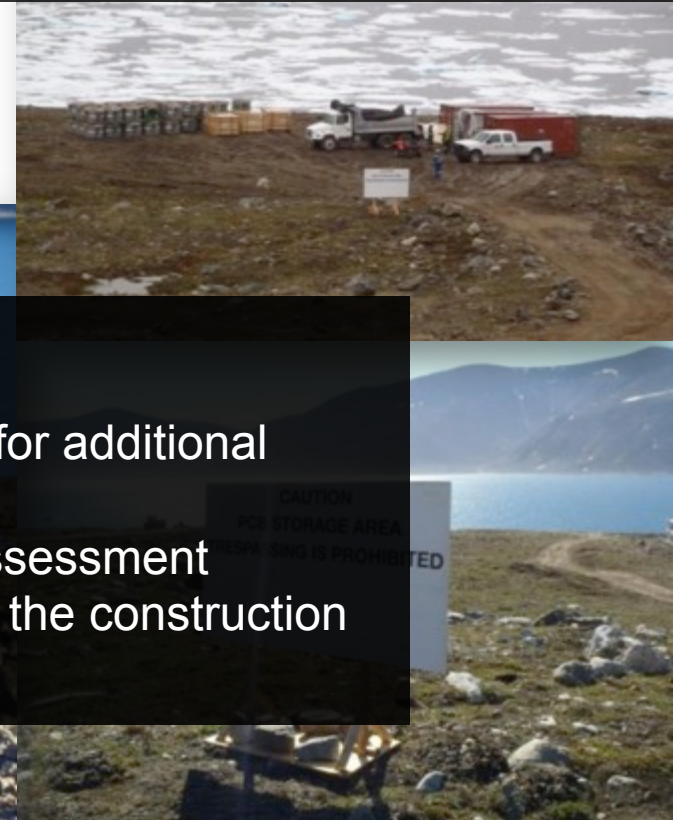
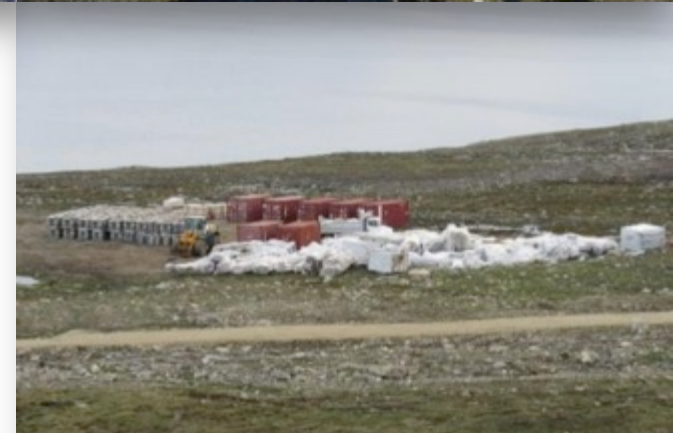
Building Materials

- Additional sampling of building materials in 2014
- Total increase of PAP material: 580 m³
- 24 additional marine containers required

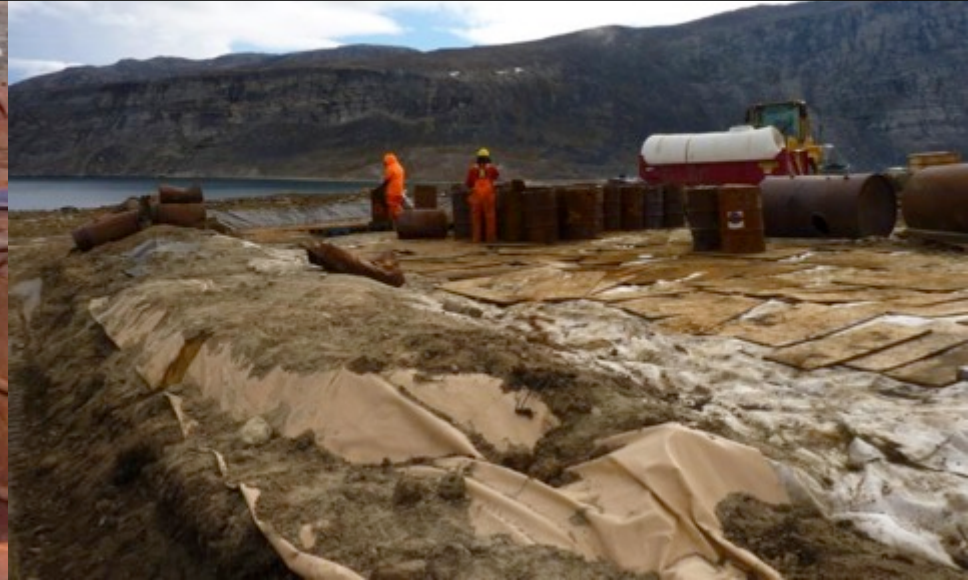
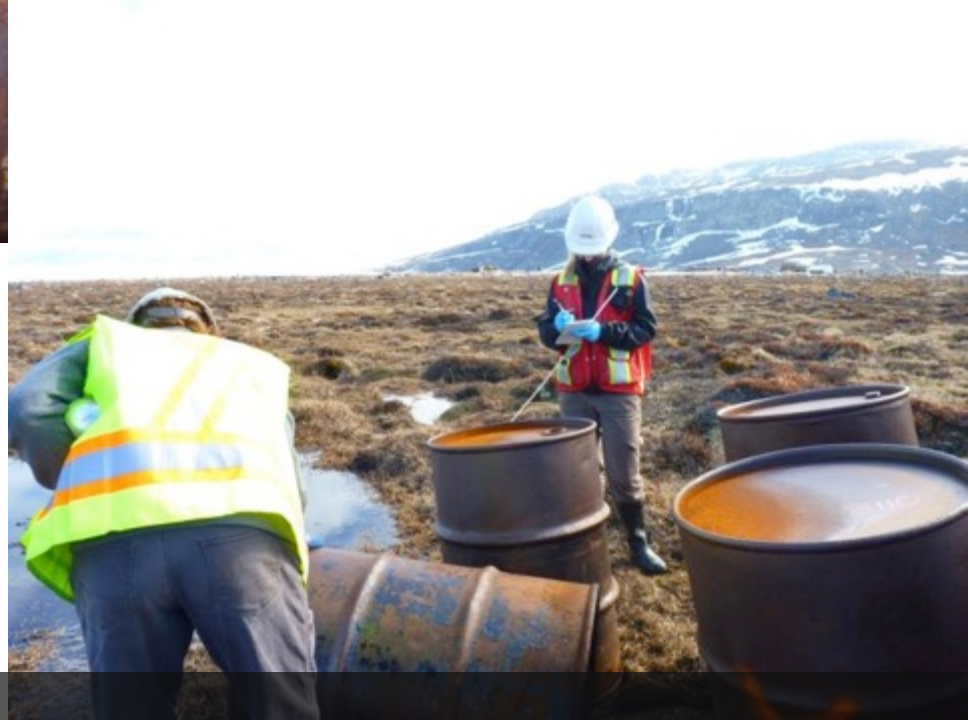
Barrel Processing

- Collection of barrels and consolidation of like products
- Sampling of contents to determine disposal requirements
- Washing and crushing barrels for disposal

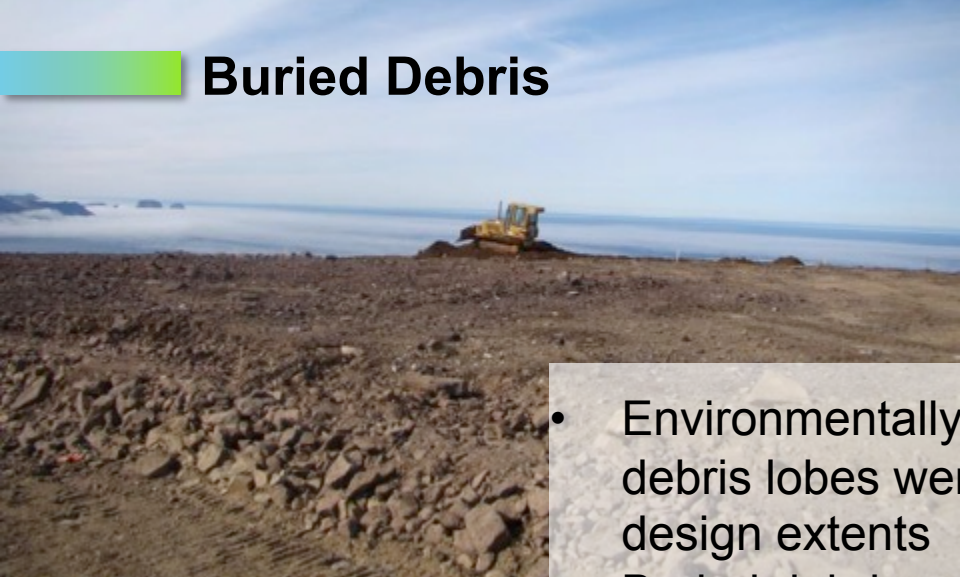
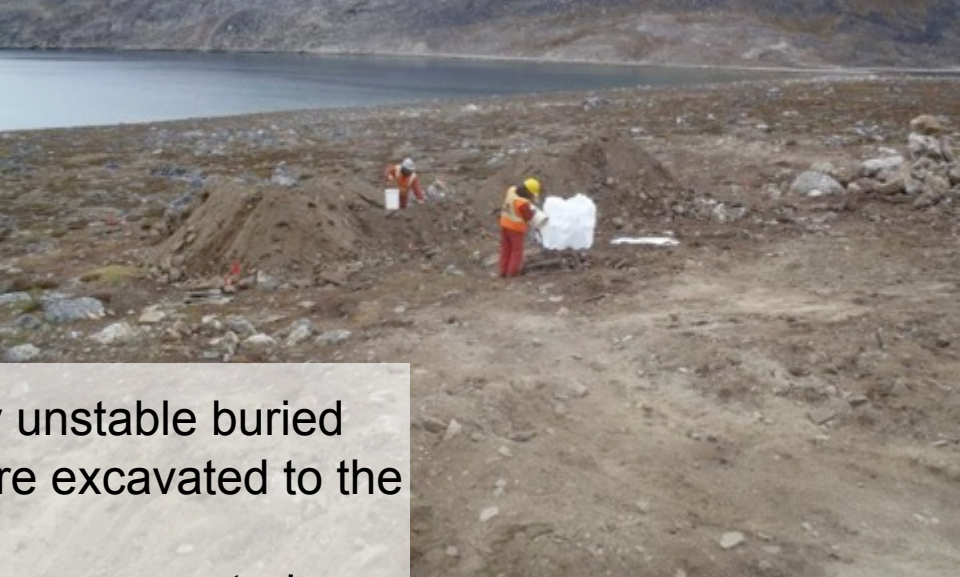
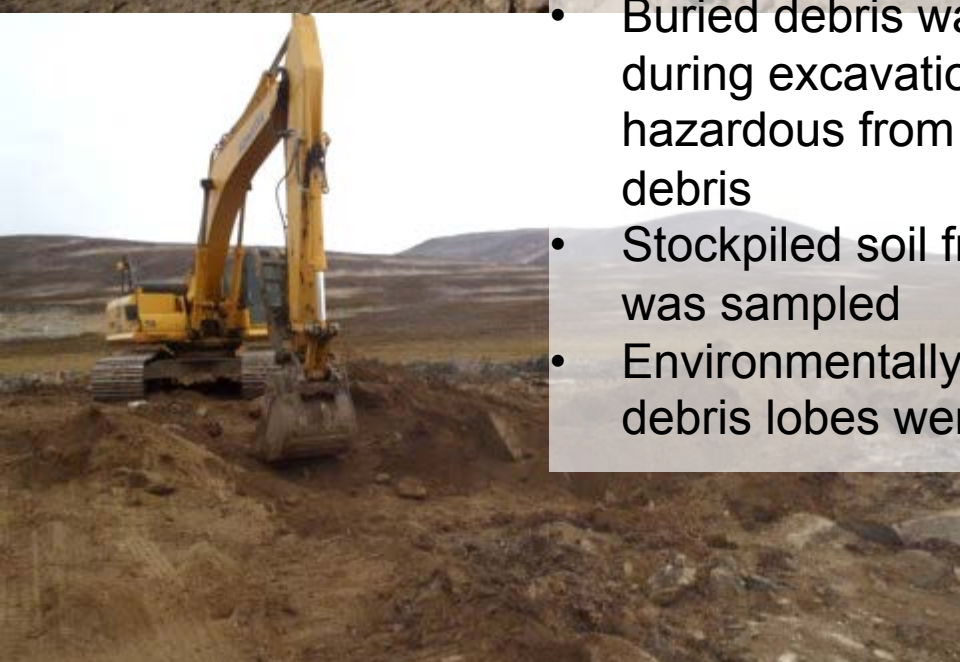
Buried Debris

- Environmentally unstable buried debris lobes were excavated to the design extents
- Buried debris was segregated during excavation to separate hazardous from non-hazardous debris
- Stockpiled soil from excavations was sampled
- Environmentally stable buried debris lobes were regraded

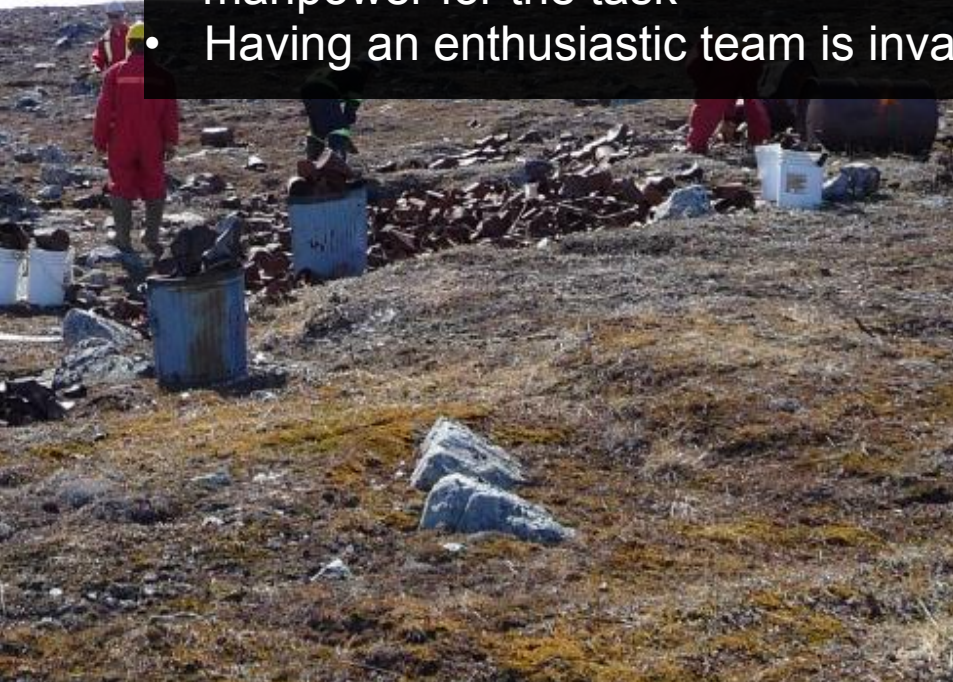
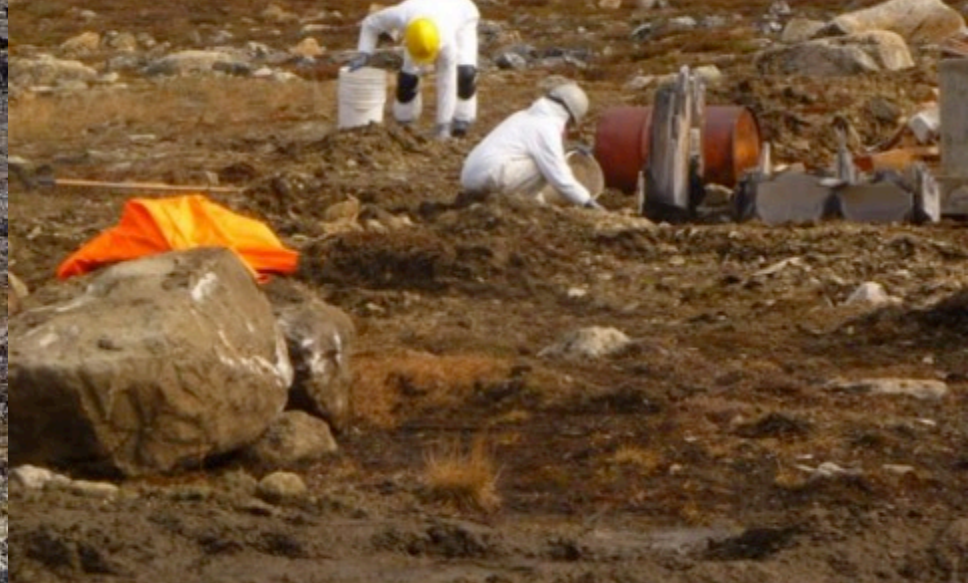
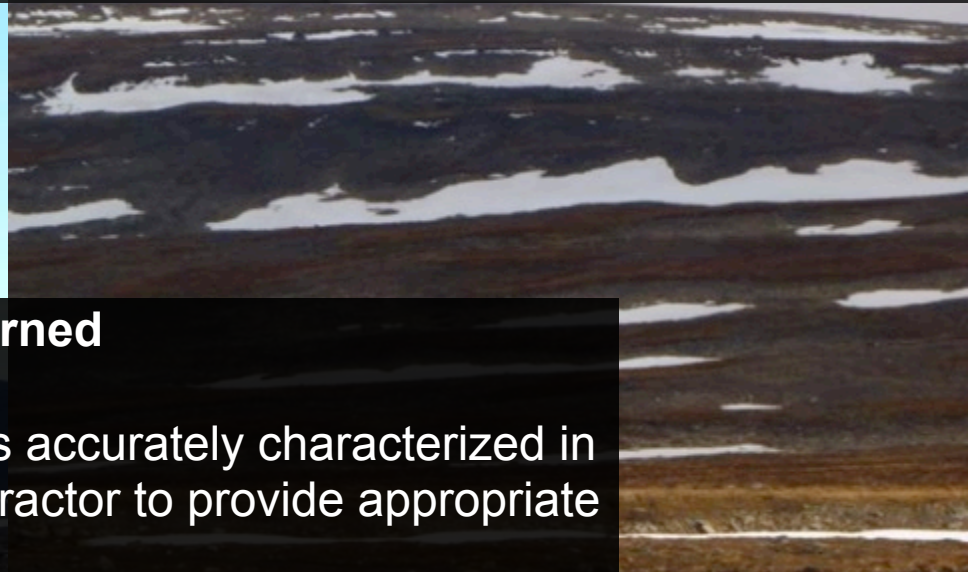
Unique Challenge – Widespread Surface Debris Padloping Island

- The concentration of the debris was accurately characterized in the Specifications allowing the contractor to provide appropriate manpower for the task
- Having an enthusiastic team is invaluable

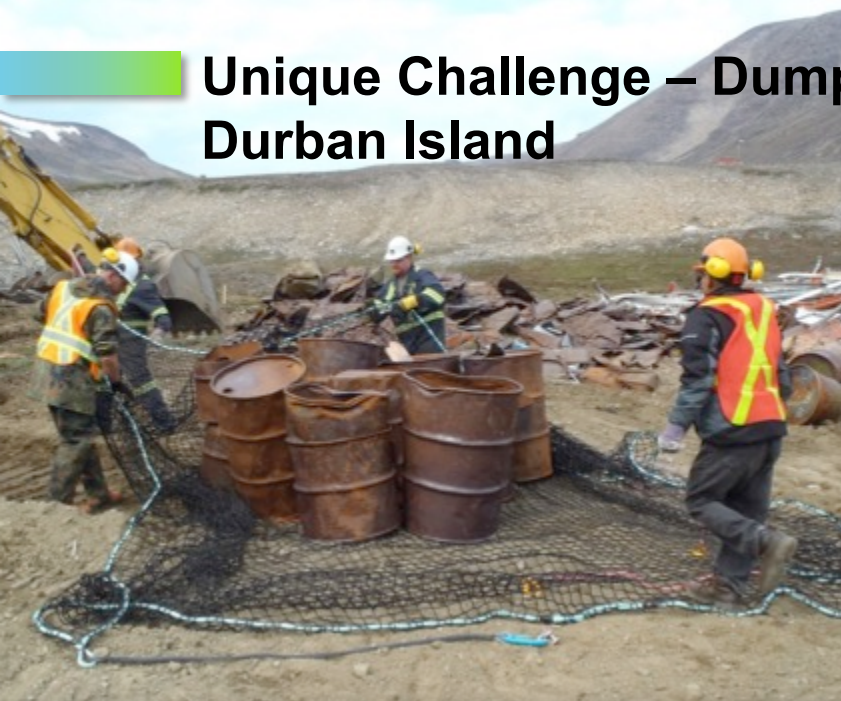
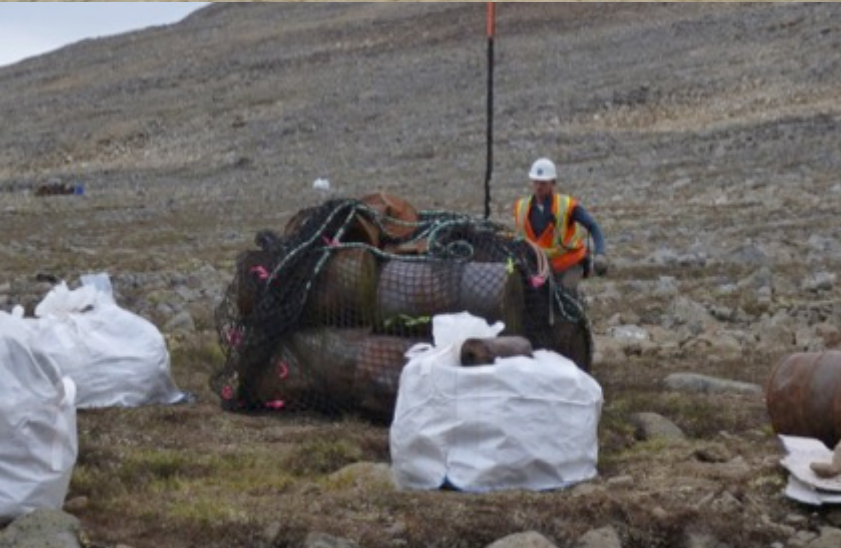
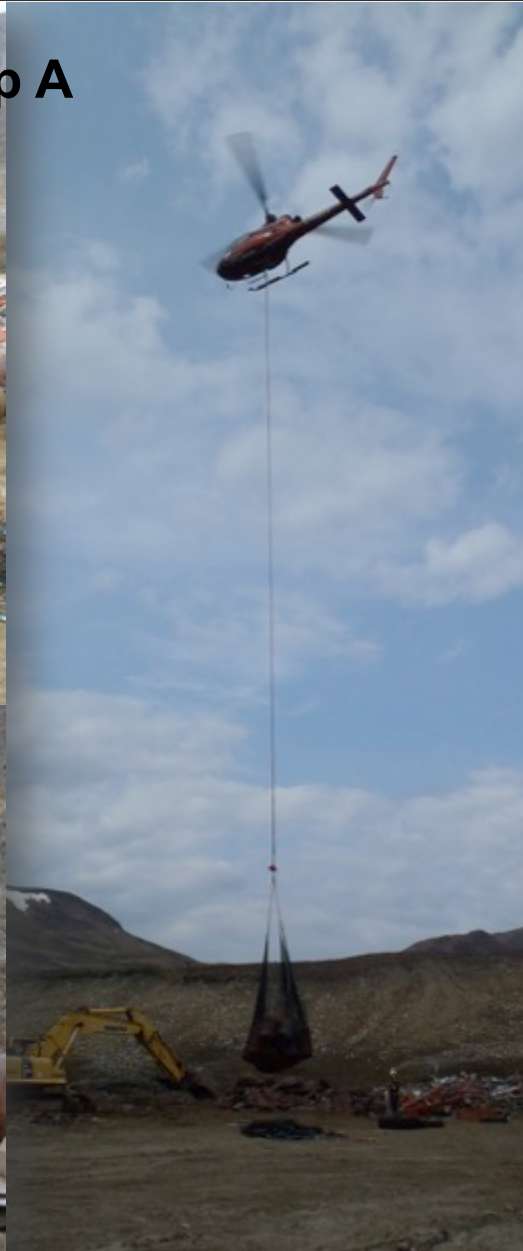
Unique Challenge – Dump A Durban Island

Debris Removal

- All debris removed by slinging loads with a helicopter
- Debris removal required three separate teams: debris collection and packaging team, sling foreman at Dump A and sling foreman at Temporary Storage Area
- An estimated 450 m³ of debris was removed
- Removal of debris was completed over 8 weeks

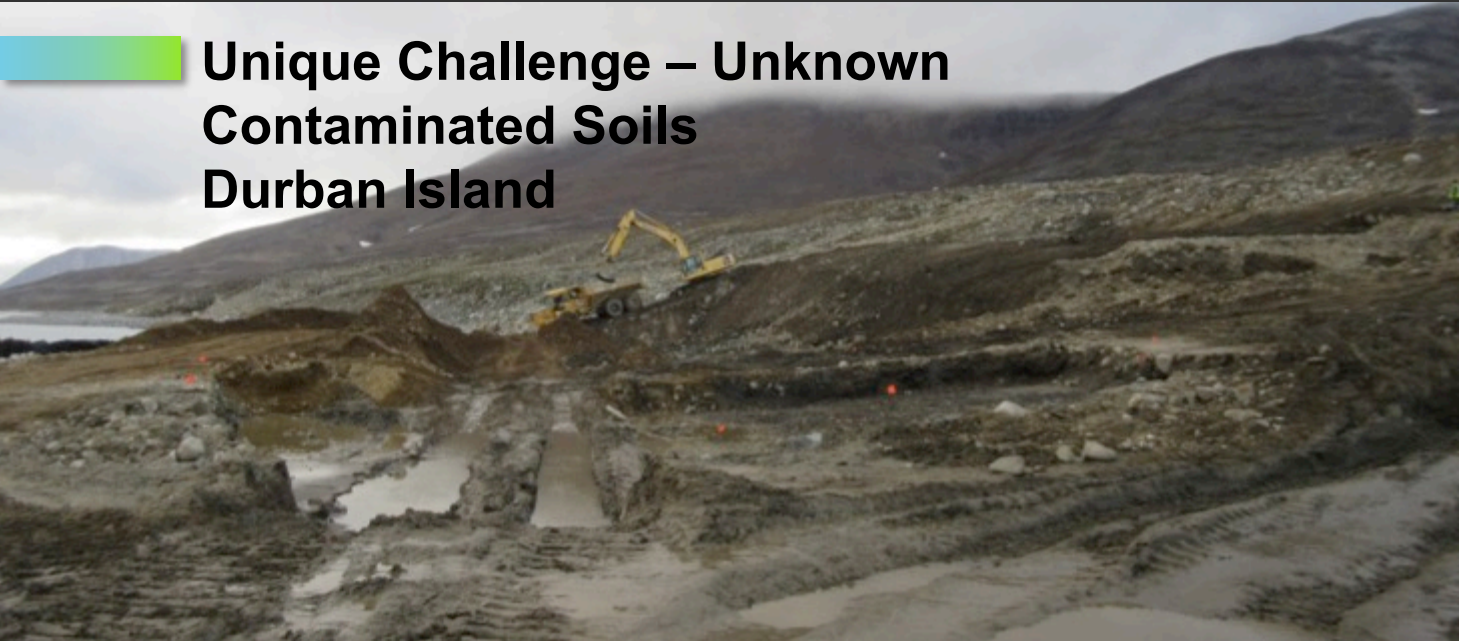
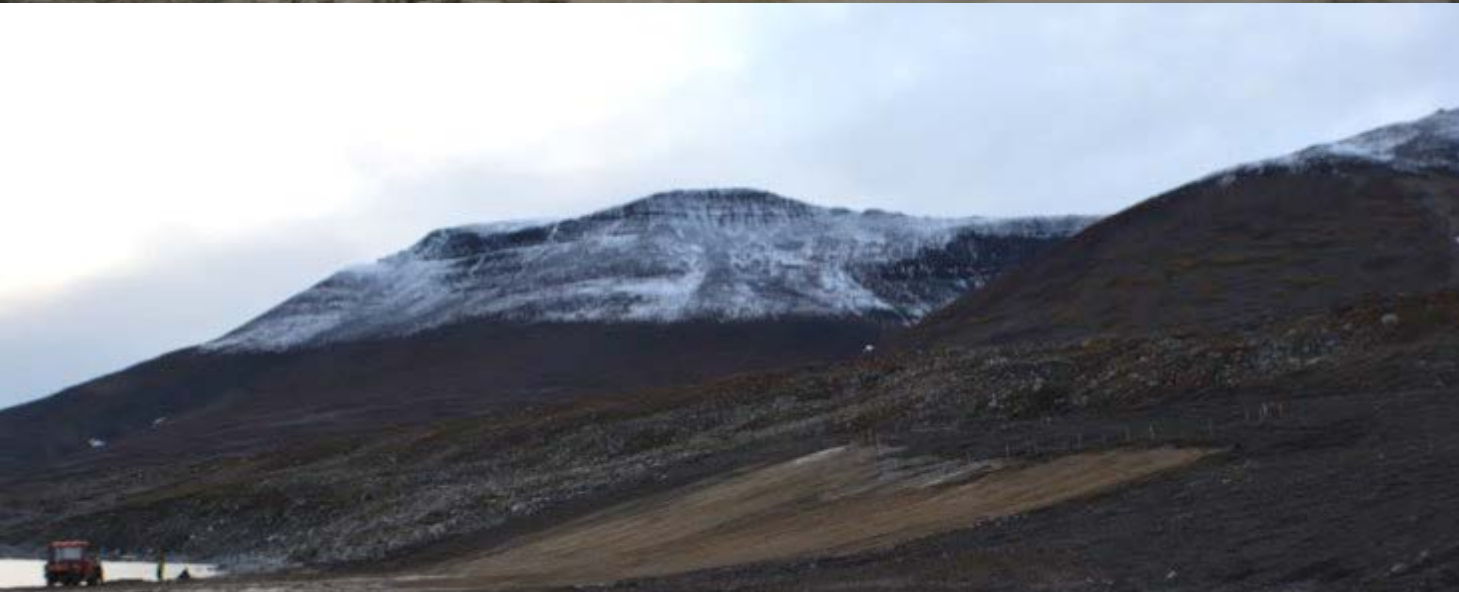
Unique Challenge – Unknown Contaminated Soils Durban Island

Soil Disposal and Treatment

- 5% of soil was treated in on-site landfarm
- 50% of soil was placed in the Soil Disposal Area
- 46% of soil was used as cover for the Soil Disposal Area

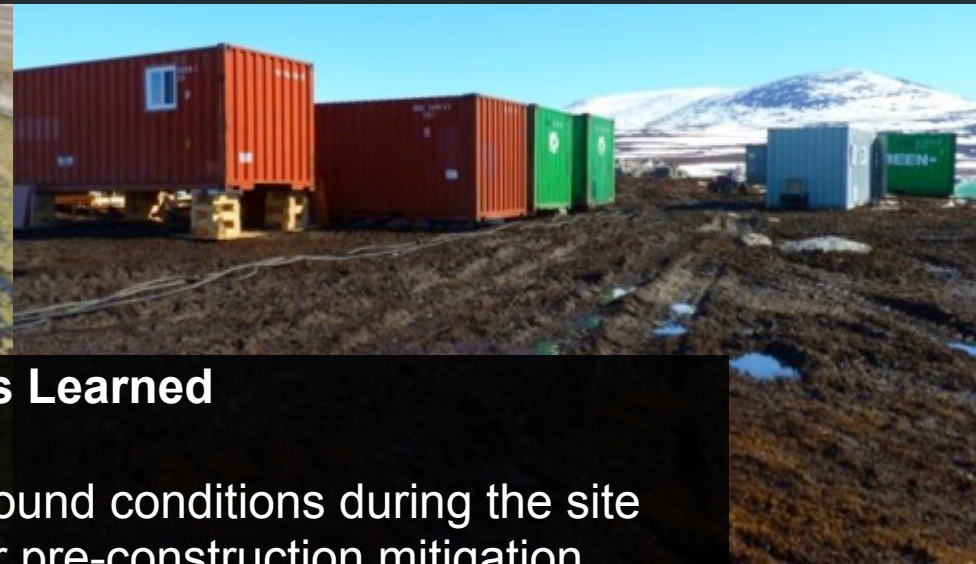
Unique Challenge – Difficult Ground Conditions Padloping Island

Lessons Learned

- Accurate documentation of ground conditions during the site assessment phase allowed for pre-construction mitigation
- Stage construction activities to avoid difficult ground conditions
- Allocate additional time and resources to manage difficult conditions
